**U.S. ENVIRONMENTAL PROTECTION AGENCY
REGION III
CLEAN WATER ACT
COMPLIANCE INSPECTION REPORT**

Name of Facility: Super Salvage, Inc.
Facility Address: 1711 1st St SW Washington, DC 20024
Mailing Address: 1711 1st St SW Washington, DC 20024

Inspection Date: February 20, 2013
Entry Time: 1:40 pm EST
Exit Time: 3:30 pm EST

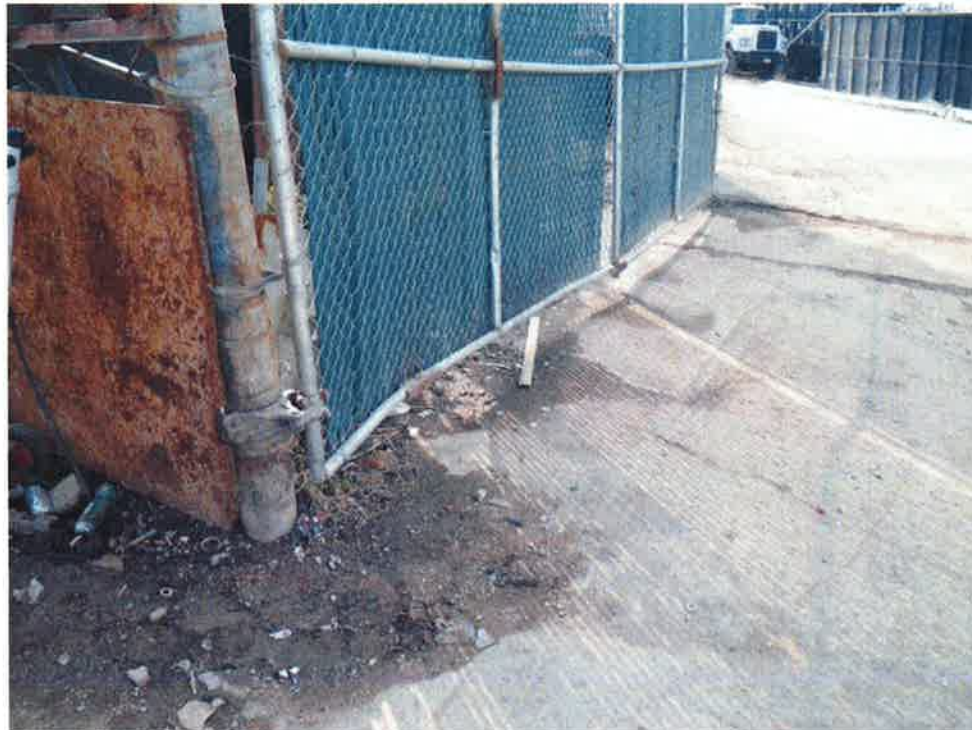
sediment entering a storm drain from the street (see Photograph 1, 53, 56, 58-64, and 79-81 in Appendix B).

Photograph 56. Staining passing under the property fence onto the District of Columbia (DC) property near Entrance 2.

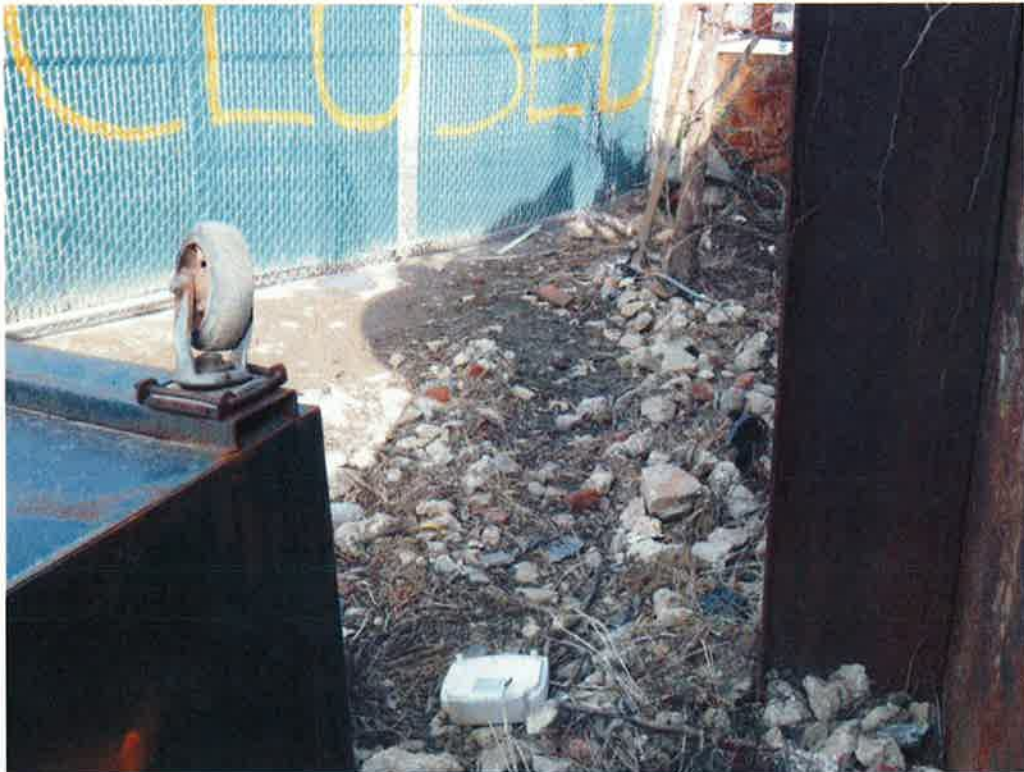
Photograph 59. View of debris around Entrance 2 and staining on the ground.

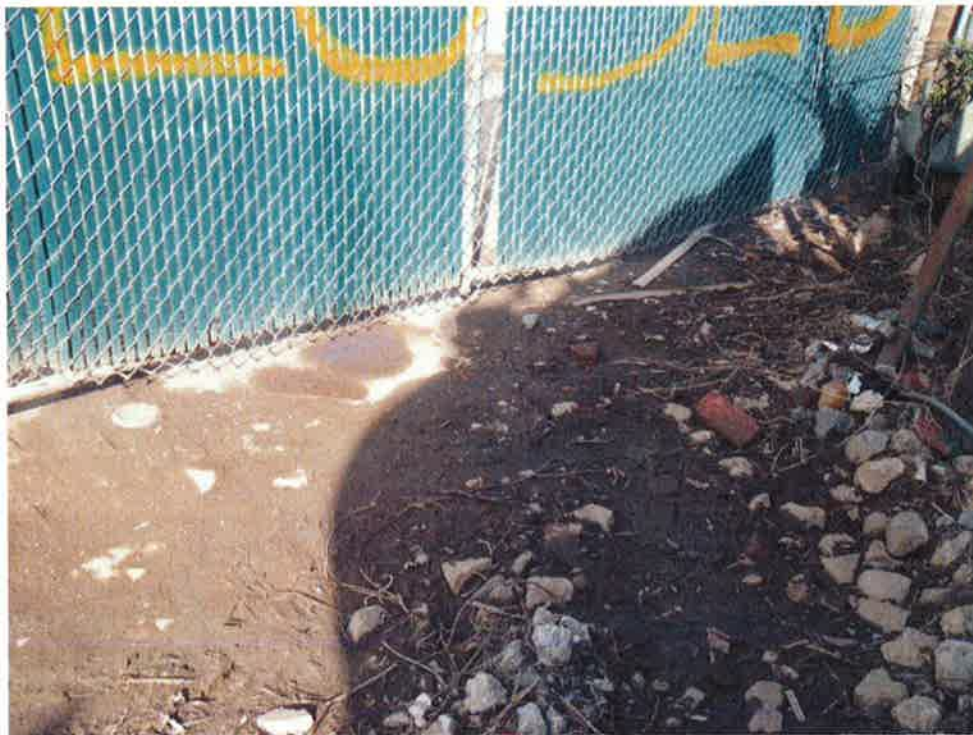
Photograph 60. Alternate view of Entrance 2 to show the staining is not due to shadows.

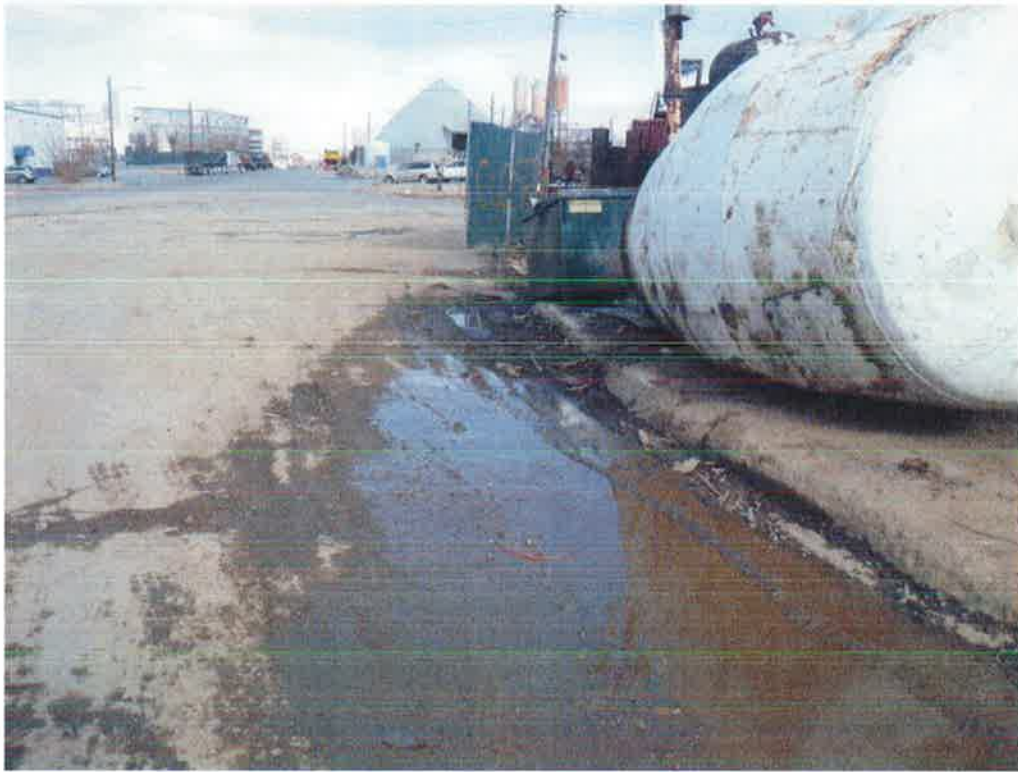
Photograph 61. Sediment residue on streets outside Entrance 2.

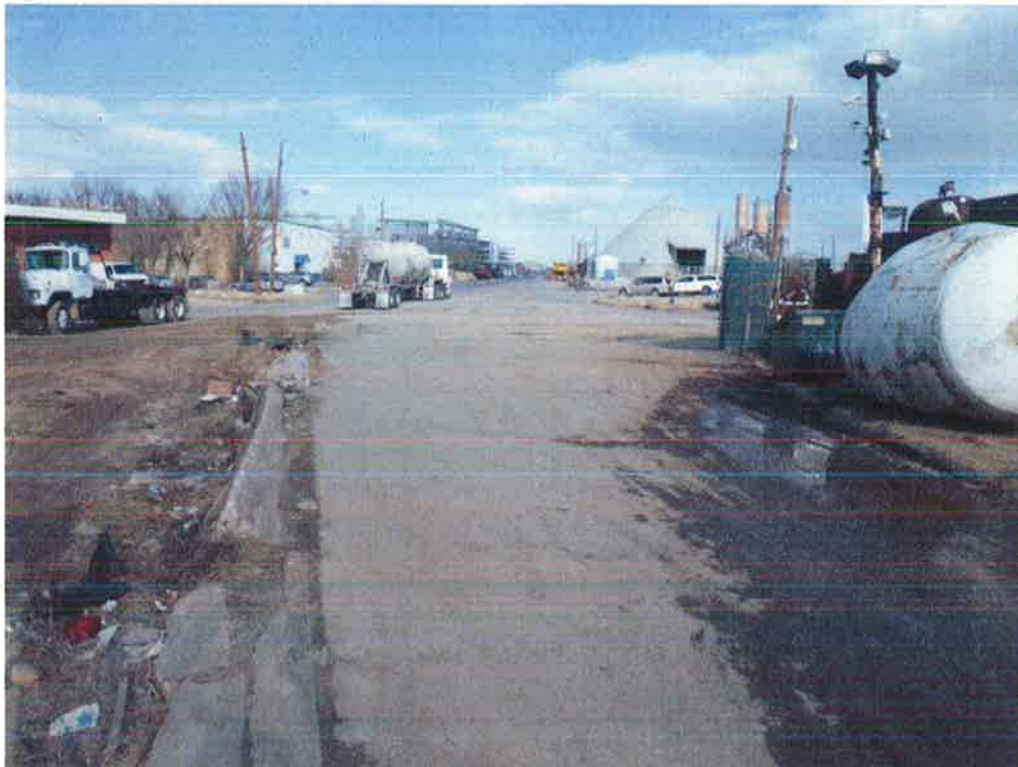
Photograph 62. Alternate view of sediment residue around Entrance 2.

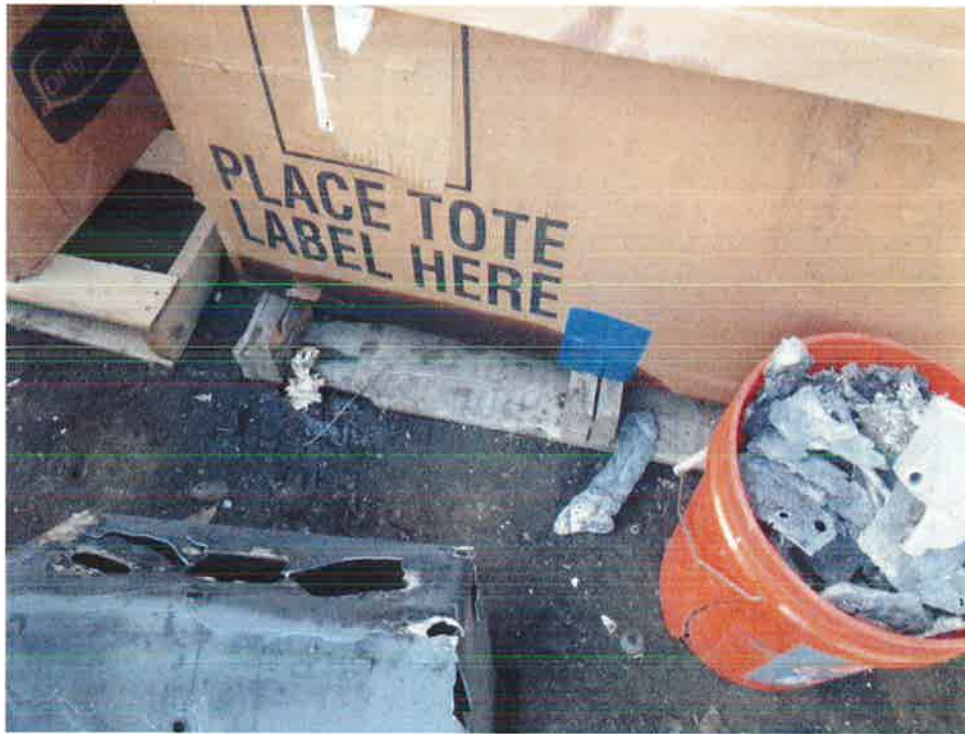
Photograph 65. Box from Photograph 66 with staining on the outside.

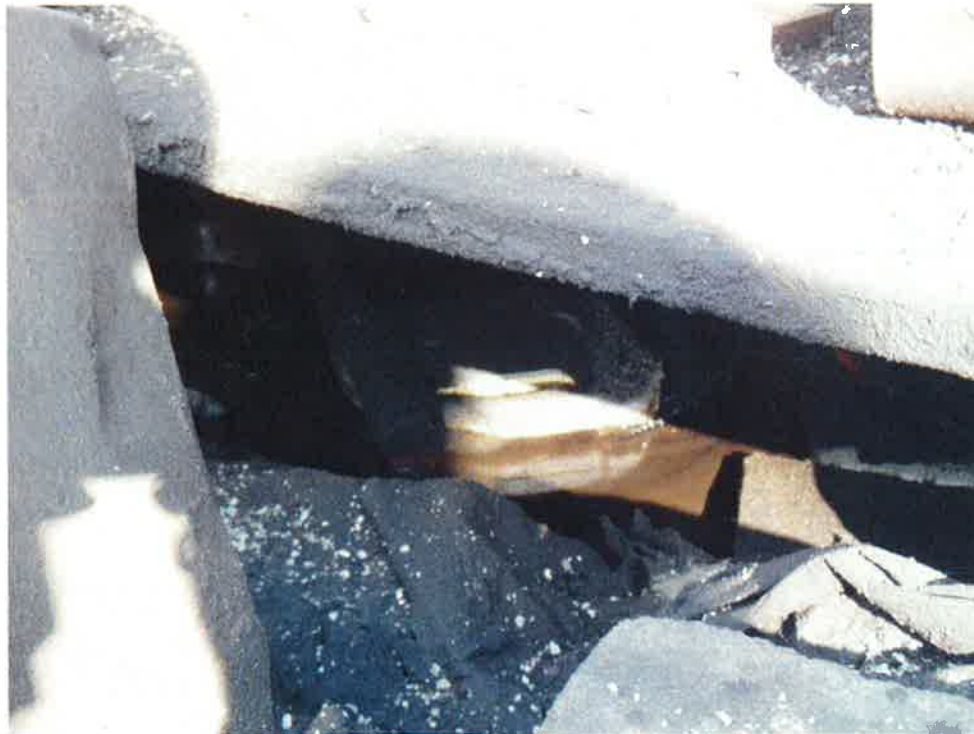
Observation 6: The EPA inspection team observed what appeared to be oil staining and pools of oil present throughout the facility (see Photographs 67 and 68 in Appendix B). In some cases saturated absorbent material was present on top of the fluid (see Photograph 70 in Appendix B). The EPA inspection team observed leaking air conditioning equipment adjacent to the property fence line (see Photographs 48, 49, and 50 in Appendix B). As stated in observation 3, the EPA inspection team observed the inside of a small building containing hydraulic equipment. The floors had saturated absorbent material located near the drums and hydraulic equipment, in addition to pooled fluids underneath the hydraulic machinery (see Photographs 20-23 in Appendix B).

Photograph 67. Close-up view of what appears to be oil pooled under tanks near Entrance 1.

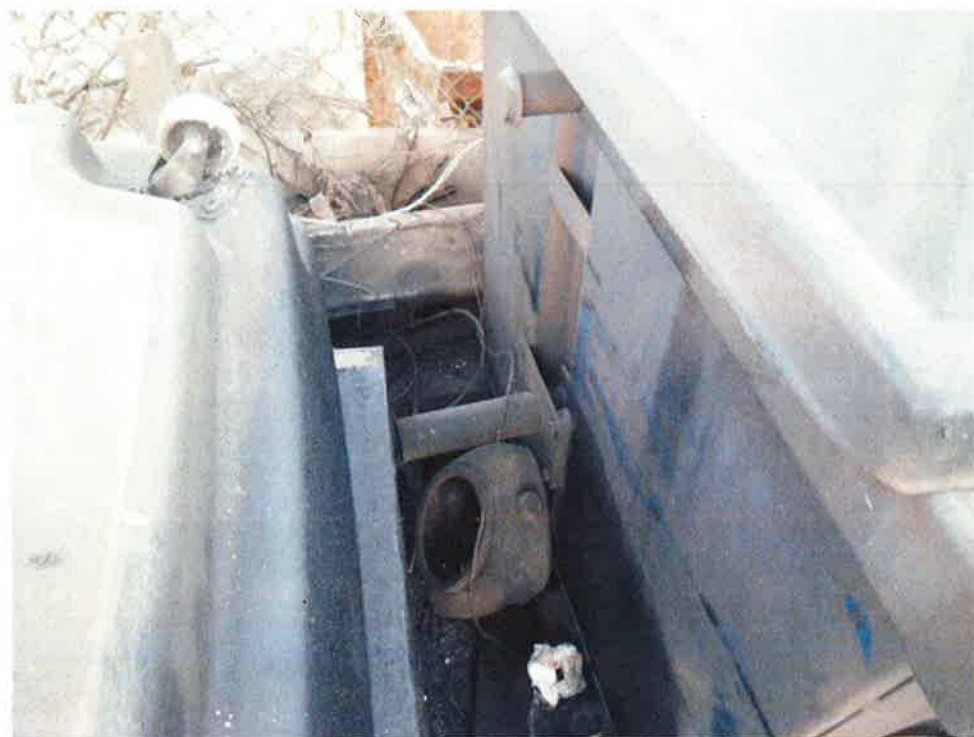
Observation 4: Super Salvage stored what appeared to be its used waste oil in an unlabeled plastic bin near Entrance 1 (see Photographs 71 and 72 in Appendix B). Several unlabeled open buckets and drums that were labeled as lubricants were also stored by the entrance on wooden pallets. It was unclear to the EPA inspection team whether the contents inside of these drums were lubricants (see Photographs 3, 4, and 70).

Photograph 72. Alternate view of container from Photograph 71 showing exterior staining.

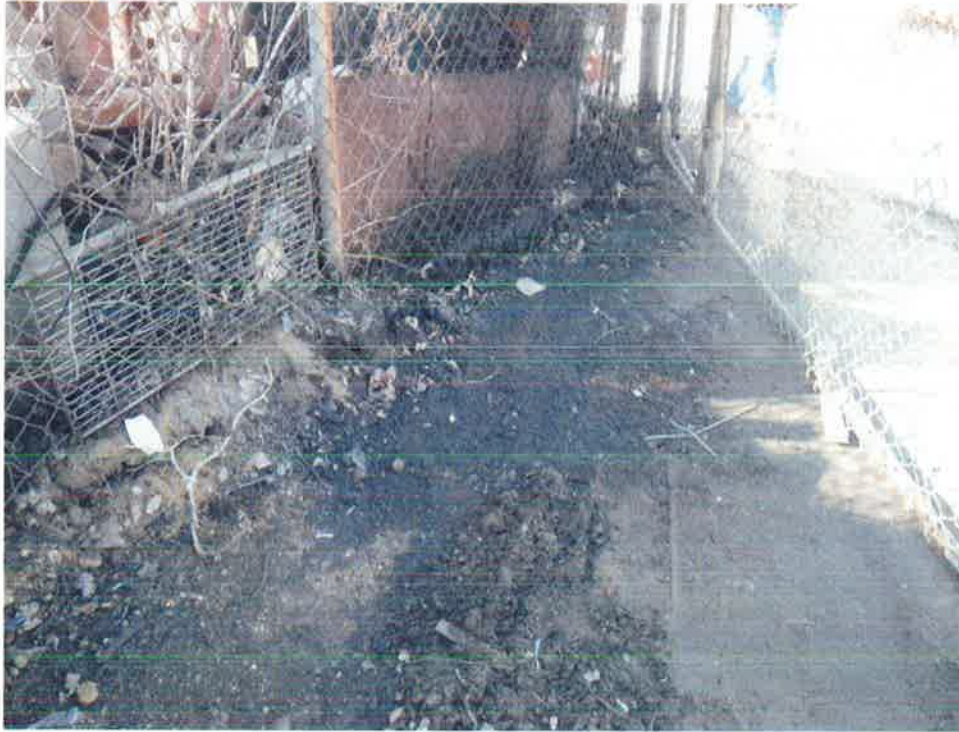
Photograph 73. View from the outside of the perimeter fence showing staining.

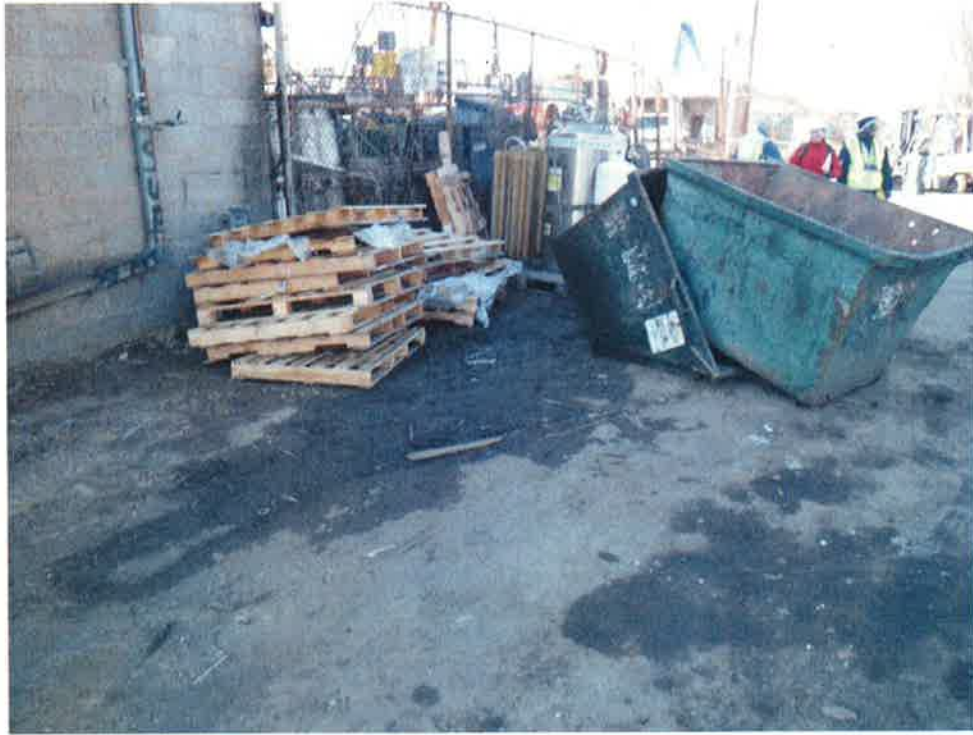
According to Mr. Bullock, there are no stormwater outfalls at the Facility and the site is designed so that stormwater does not leave the site. The perimeter of the site has a concrete curb, Entrance 1 has a berm, and Entrance 2 slopes into the Facility (see Photographs 2, 50, and 53 in Appendix B). However, in many cases, the EPA inspection team observed materials stored outside the perimeter of the Facility (see Photographs 58, 63, and 75 through 78 in Appendix B), sediment/material/liquid residue in and around the entrance and outside of the site (see Photographs 1, 3, 47, 50, 56, 61, 73, 75, 80, 83 and 84 in Appendix B), and there was evidence of what appeared to be oil staining and fluid losses beyond the curbing and berm and sediment into the storm drain near the corner of First Street SW and S Street SW (see Photographs 75, 79, 80, 81, 83, and 84 in Appendix B).

Photograph 75. **Staining on the ground outside of the perimeter fence near dumpsters.**

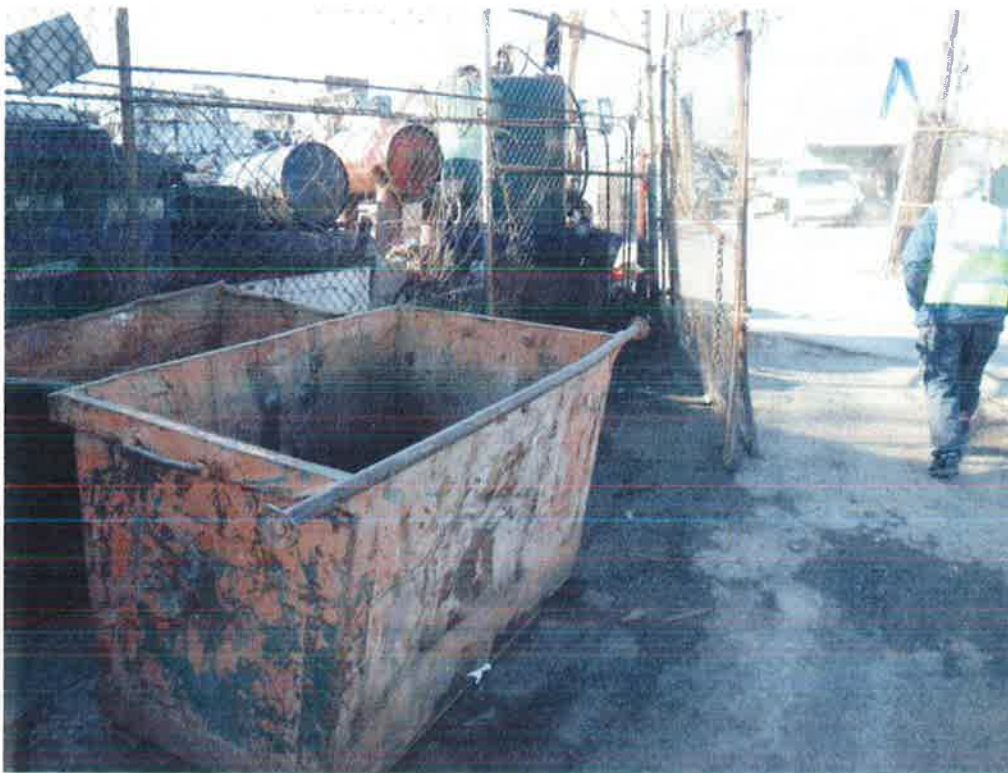
Photograph 78. **Staining and old dumpsters near Entrance 1.**

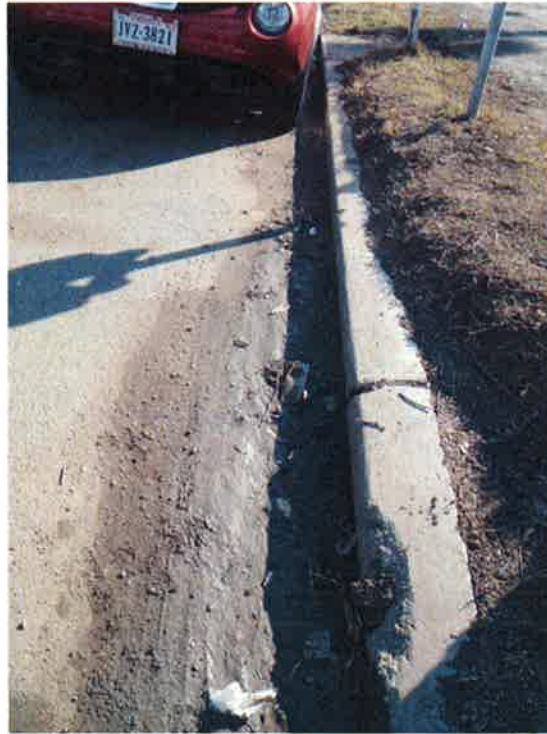
Photograph 79. Path of sediment leading from Super Salvage towards the storm drain.
Storm drain is located near the corner of First Street SW and S Street SW.

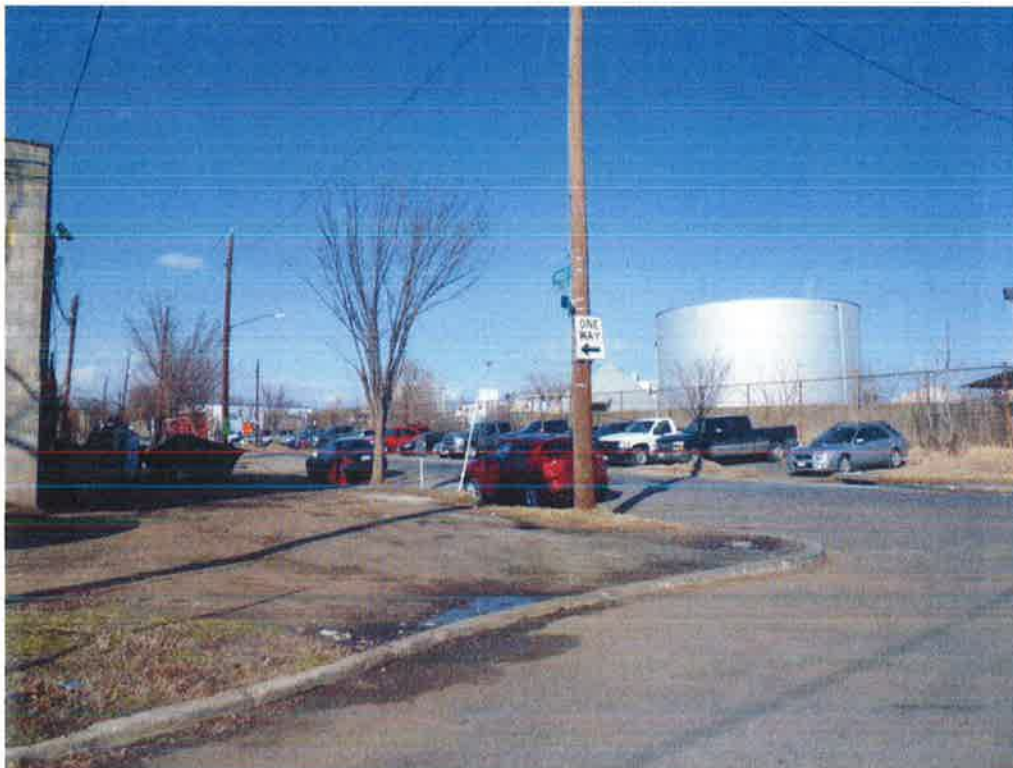
Photograph 82. Staining at the intersection of First Street SW and S Street SW.

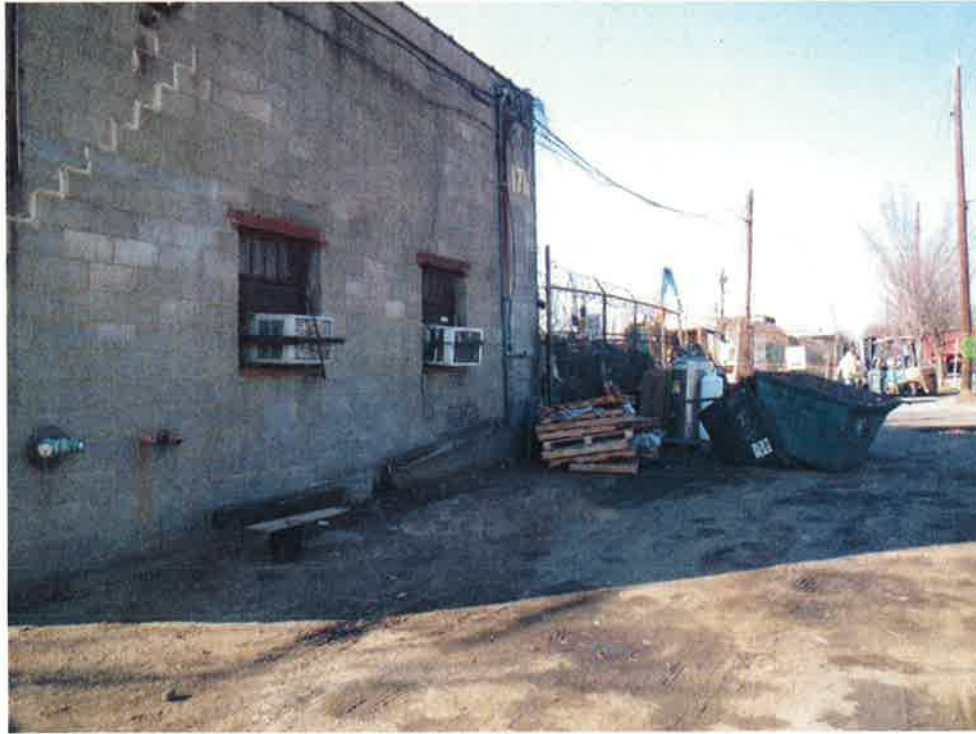
Photograph 83. View of the gutters and roof drains and the stained exterior of the facility near the corner of First Street SW and S Street SW.

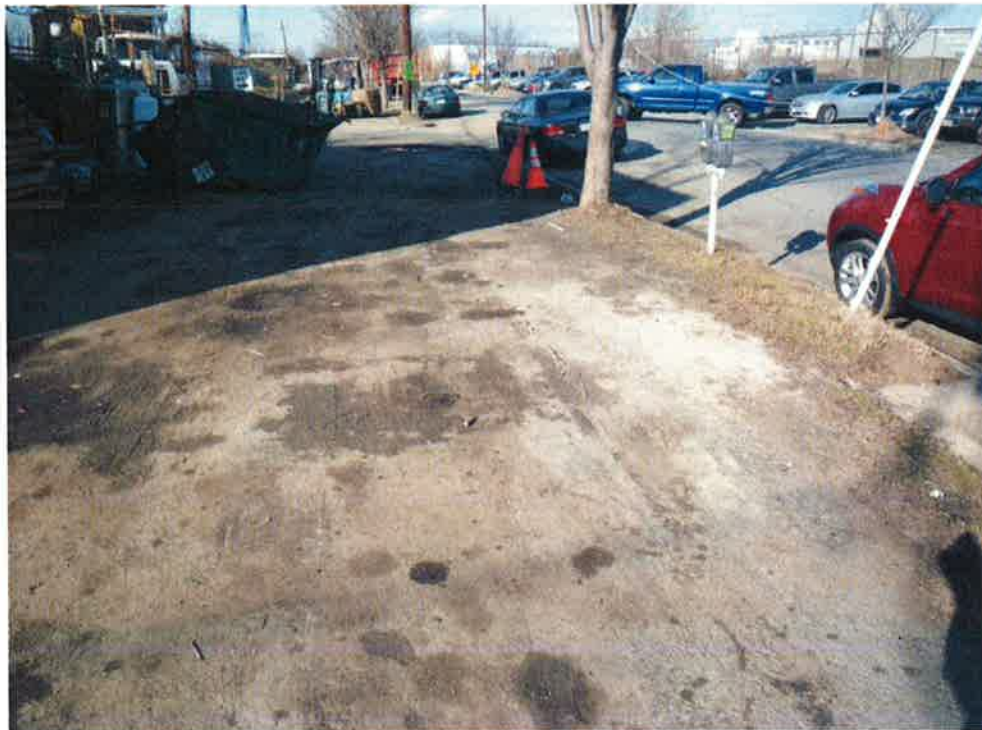
Photograph 84. Stains on the sidewalk adjacent to the site near the corner of First Street SW and S Street SW.

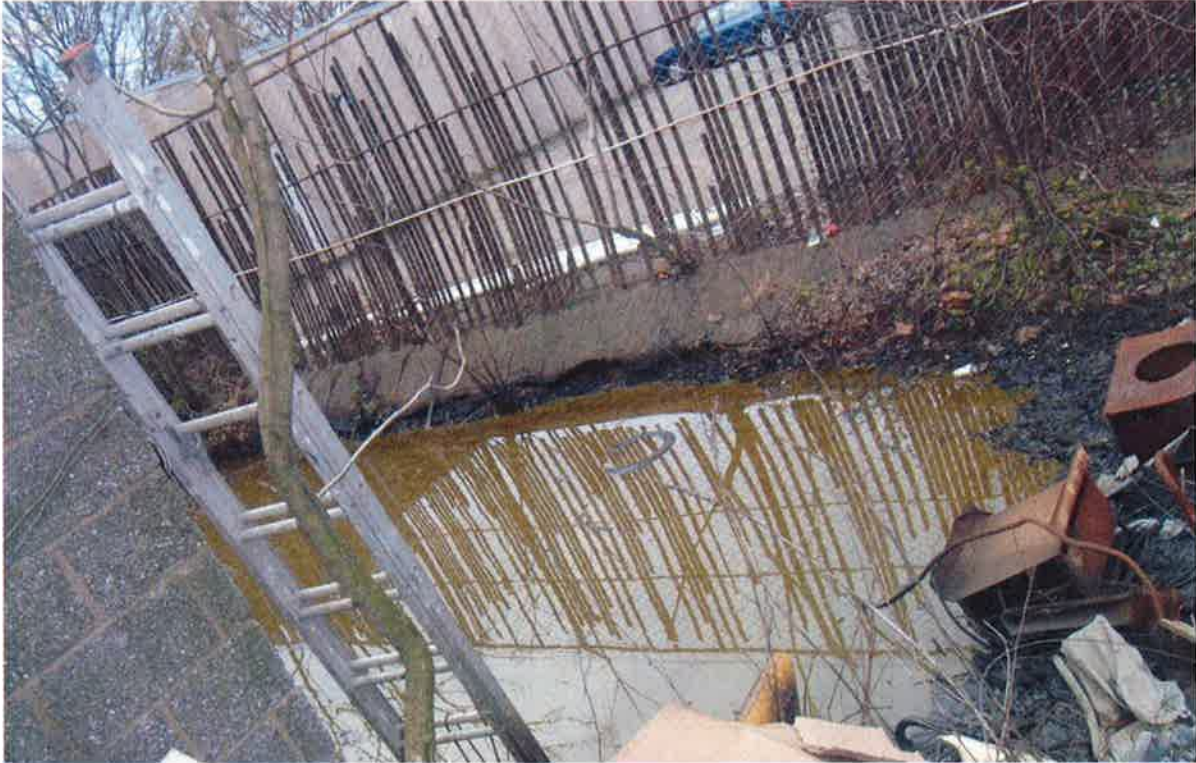
Hole in the ground with different pumped liquids at 1711 1st St., SW
